ENVIRONMENTAL COMPLIANCE OFFICERS

EXPERIENCES OF AN ECO IN MATATIELE.....

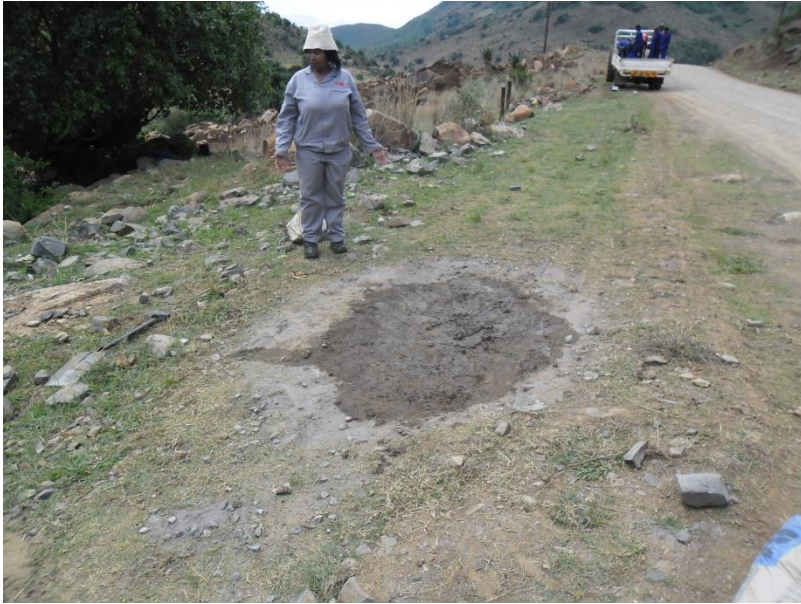
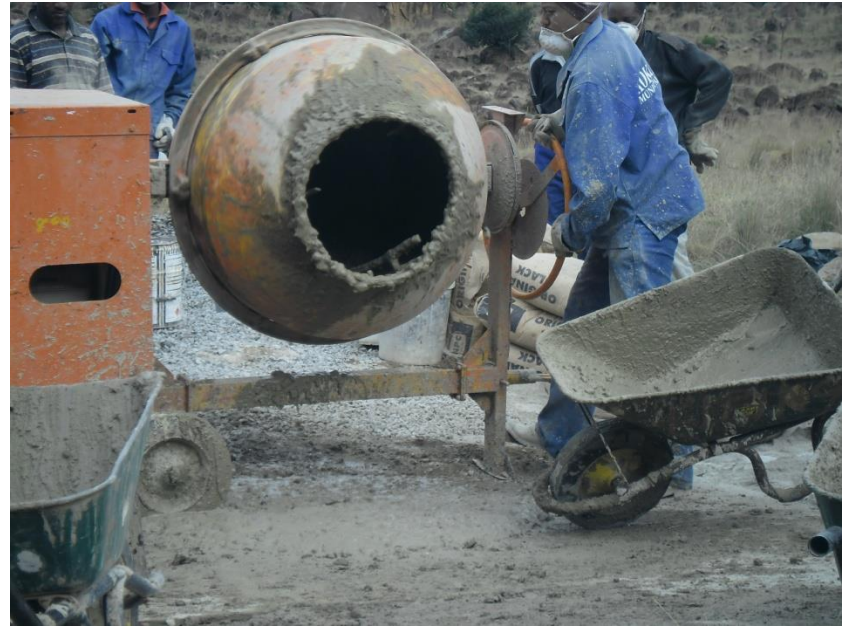
Concrete transport by wheelbarrow results in accidental spills

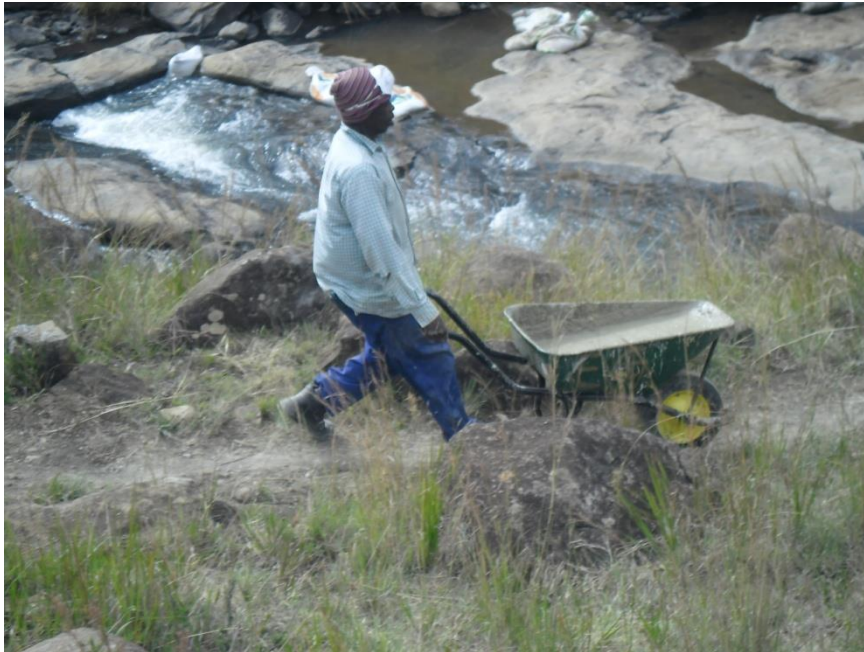
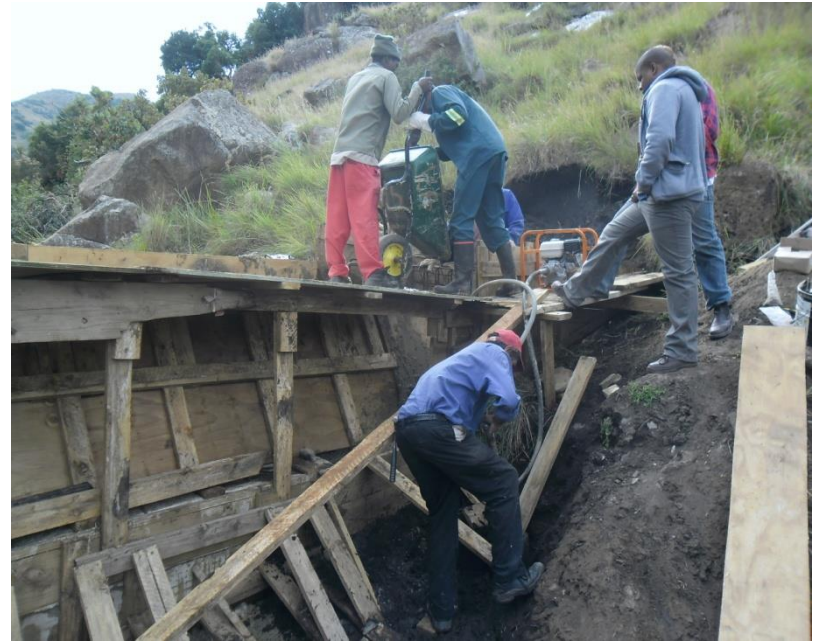
Water contamination

Breaking the concrete using Jack hammers

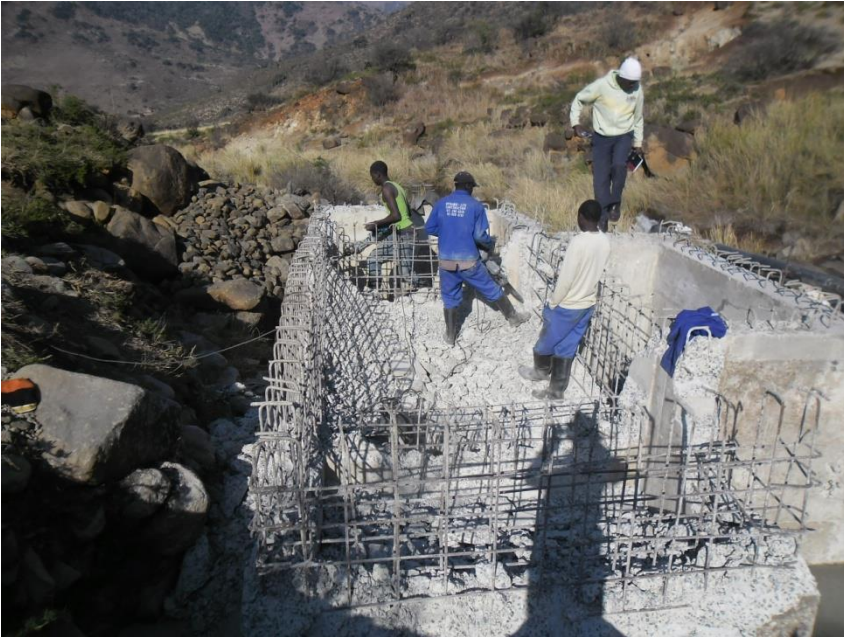
Tightening the steel bar

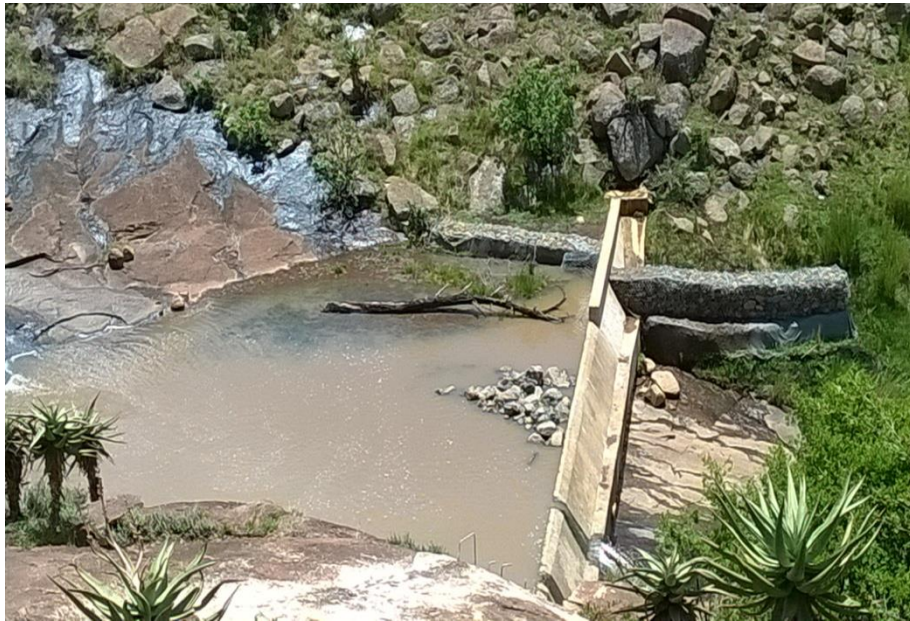
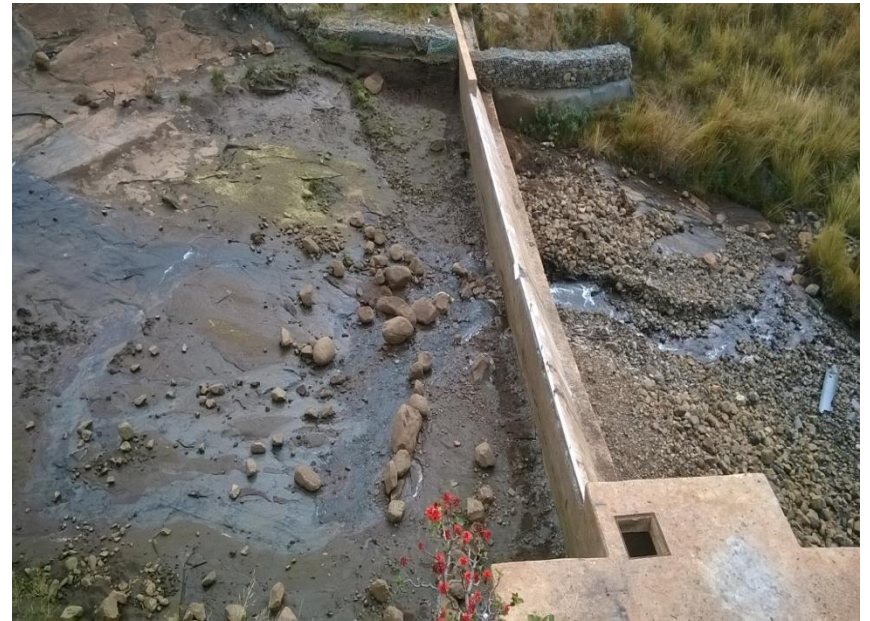
River crossing

Not diverting the water before excavation

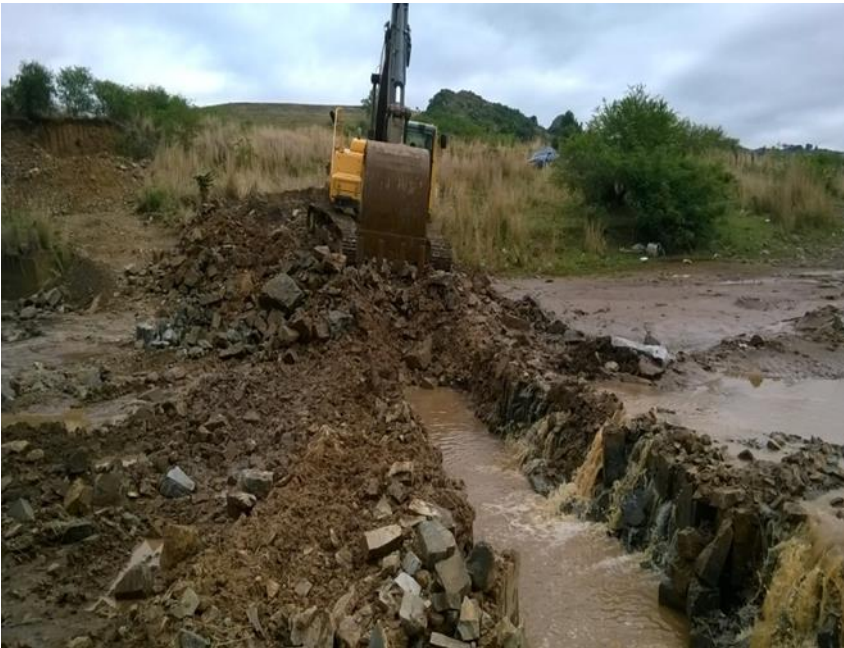
After restoration of the river bed

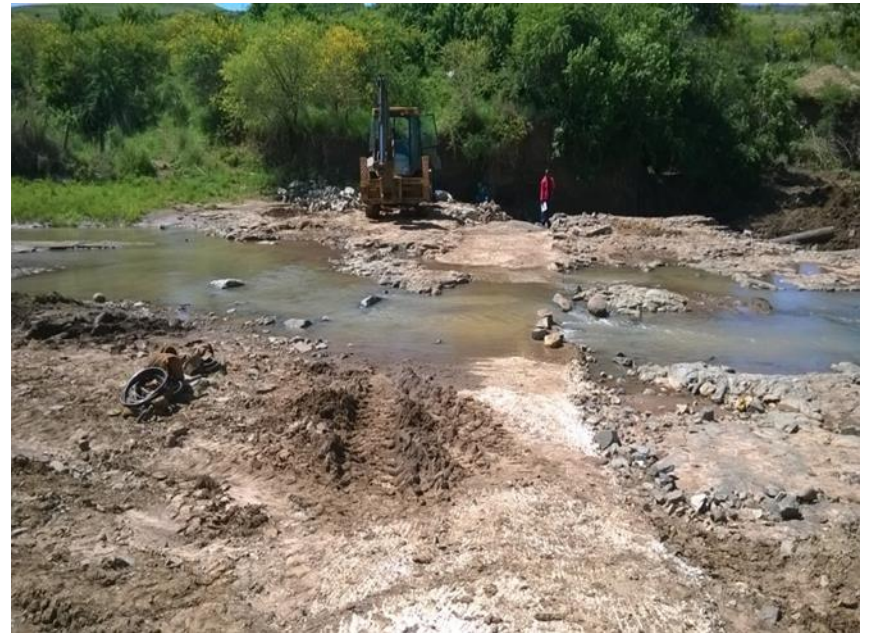
Wetland degradation

Trenching in the wetland

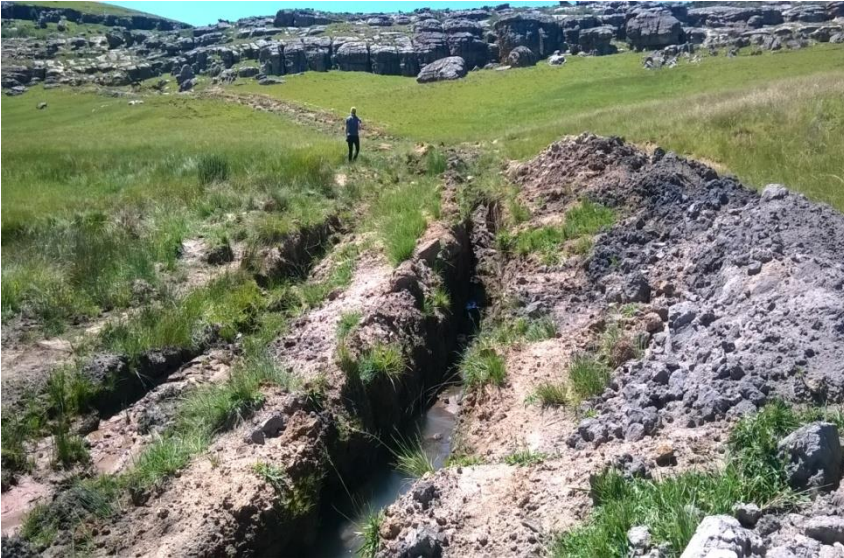
Stream blocking

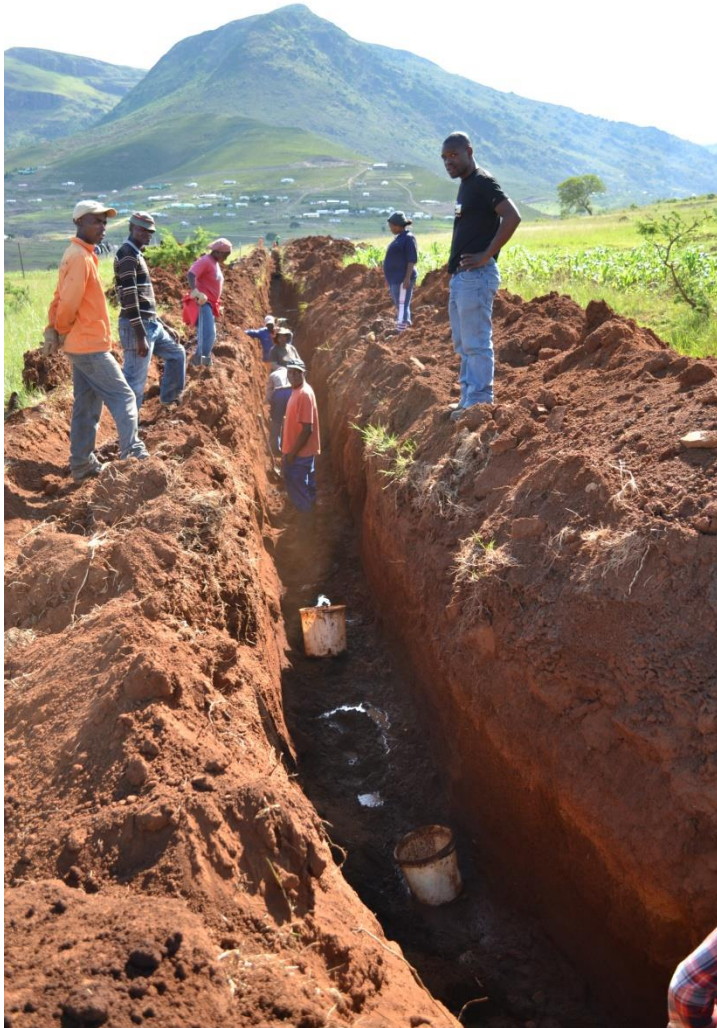
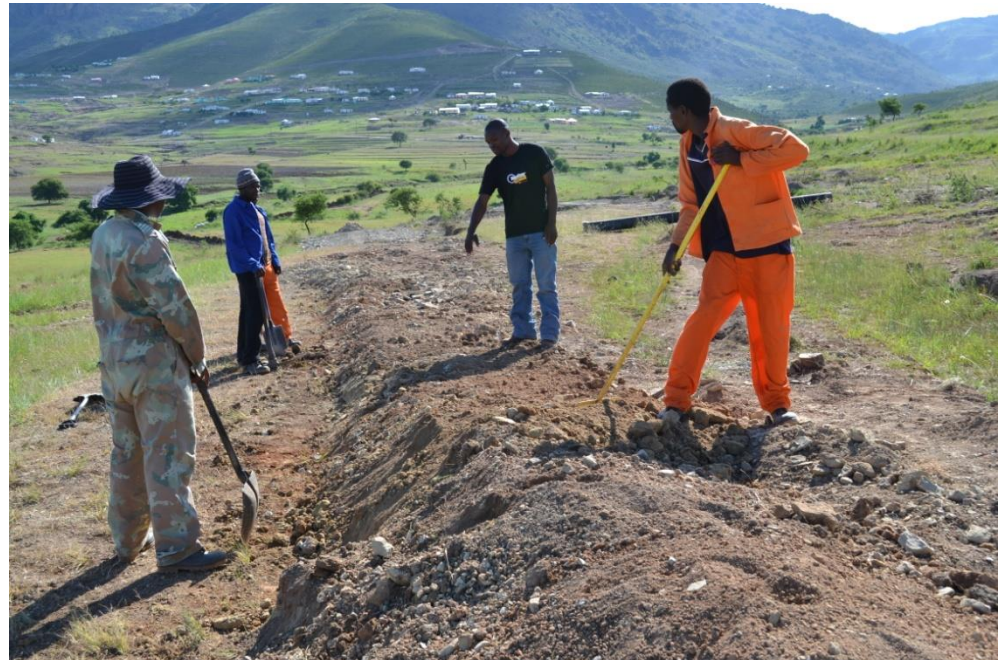
Soil erosion no top soil

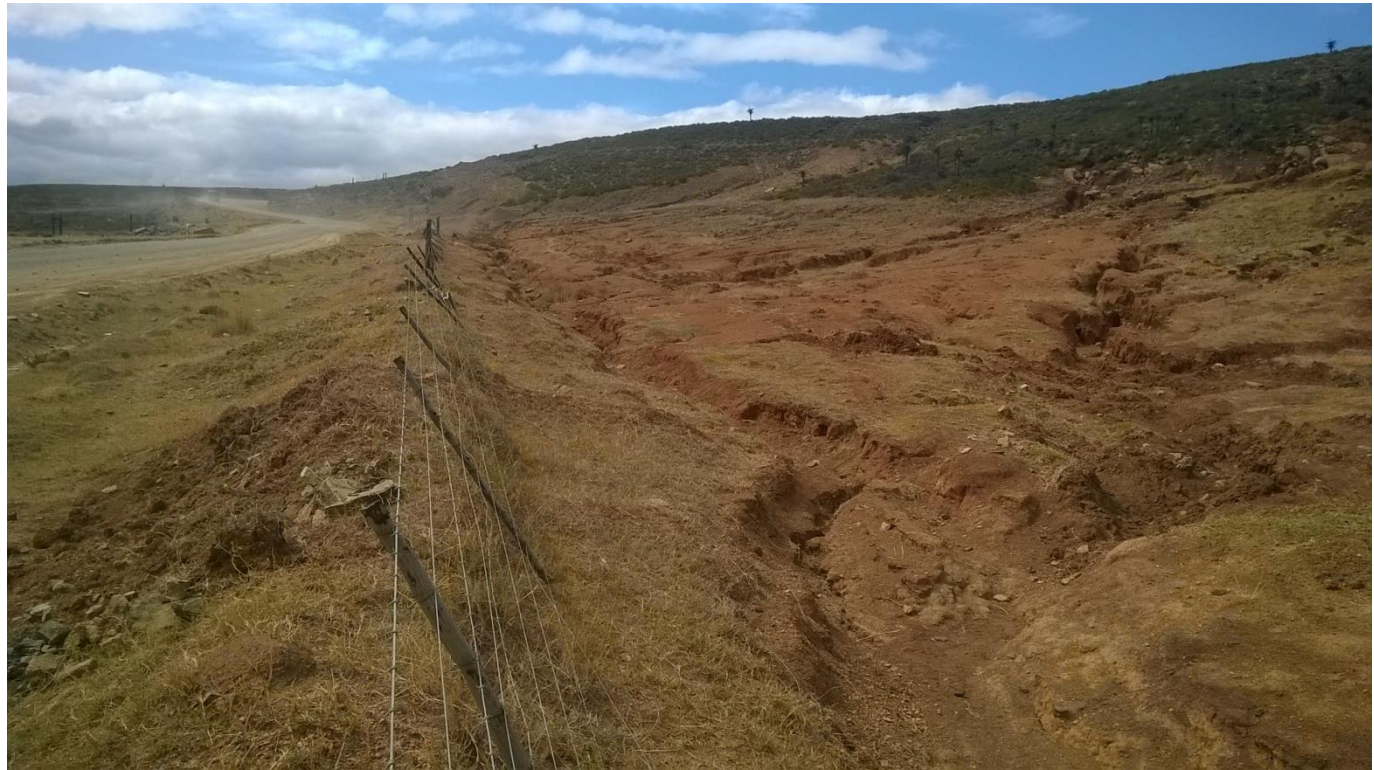
Scour needs protection

Scour valve

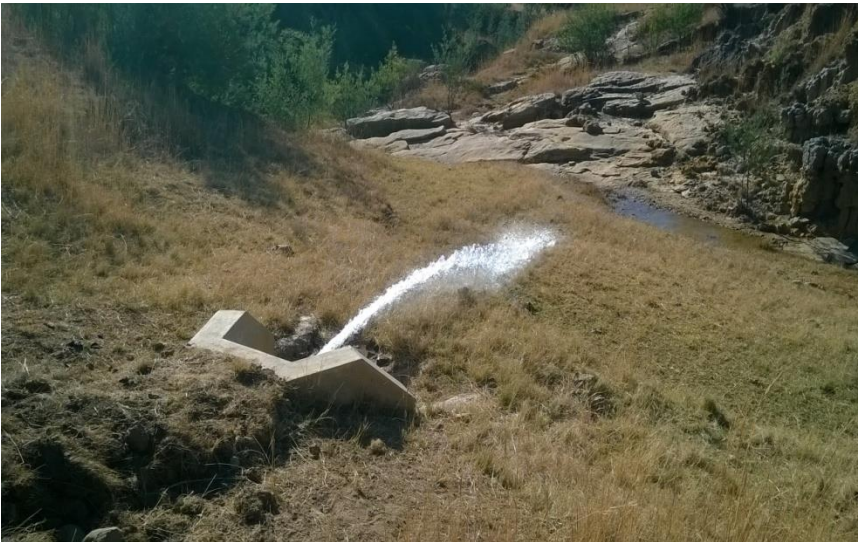
Course erosion

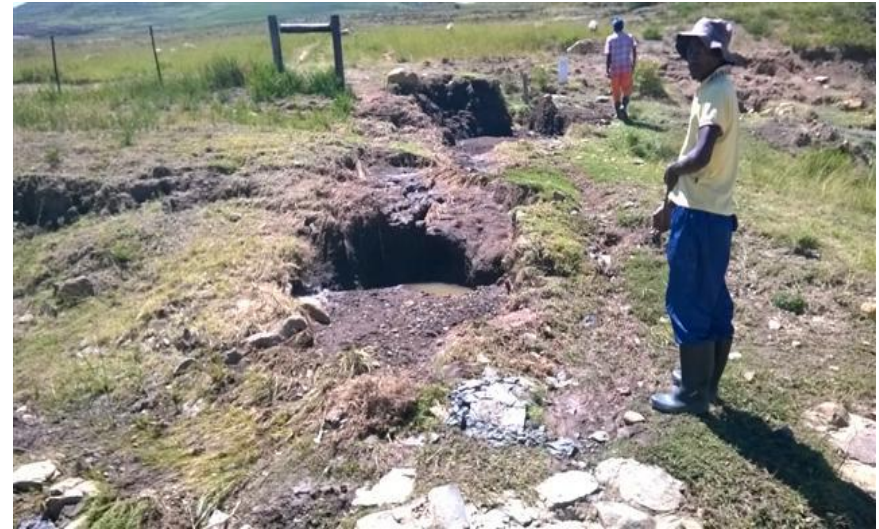
EMP guidelines not followed

**Trench left open for 2-3 weeks.
Trenches not to be left open for
more than two days.**

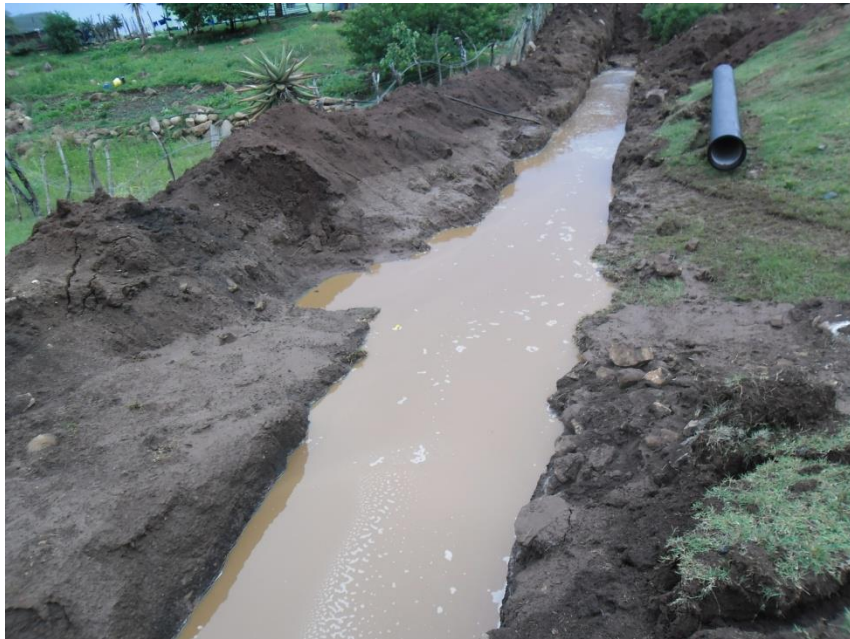
Trench wall collapsed

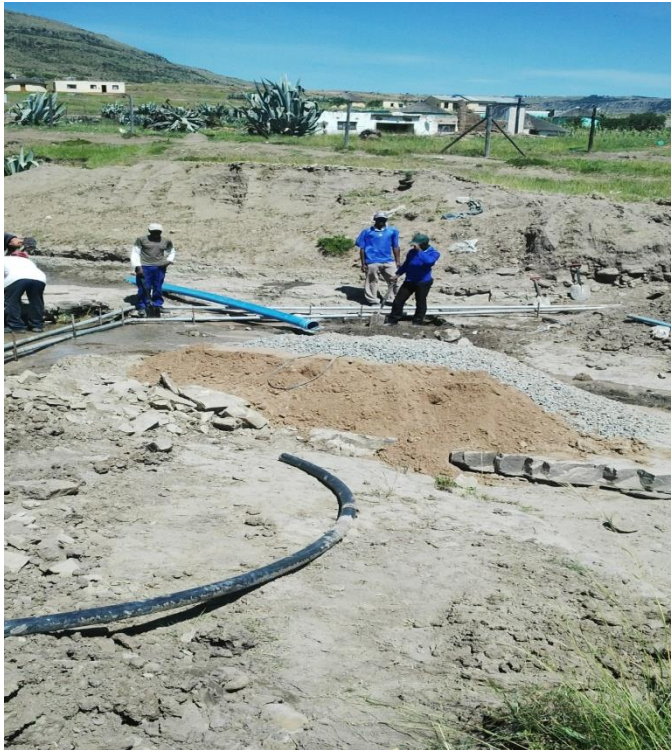
Road without ECO

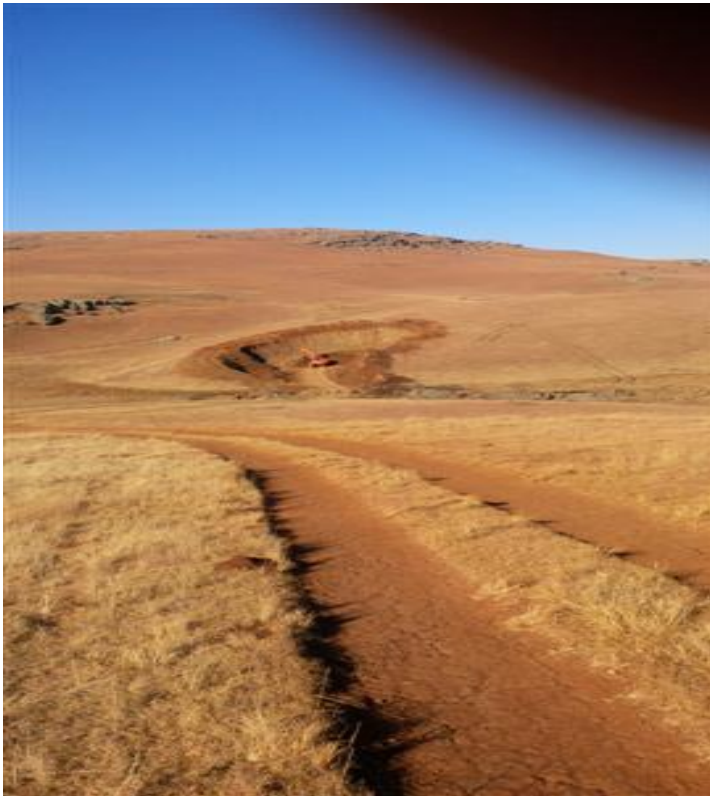
Blocking off wetland to make road to borrow pit

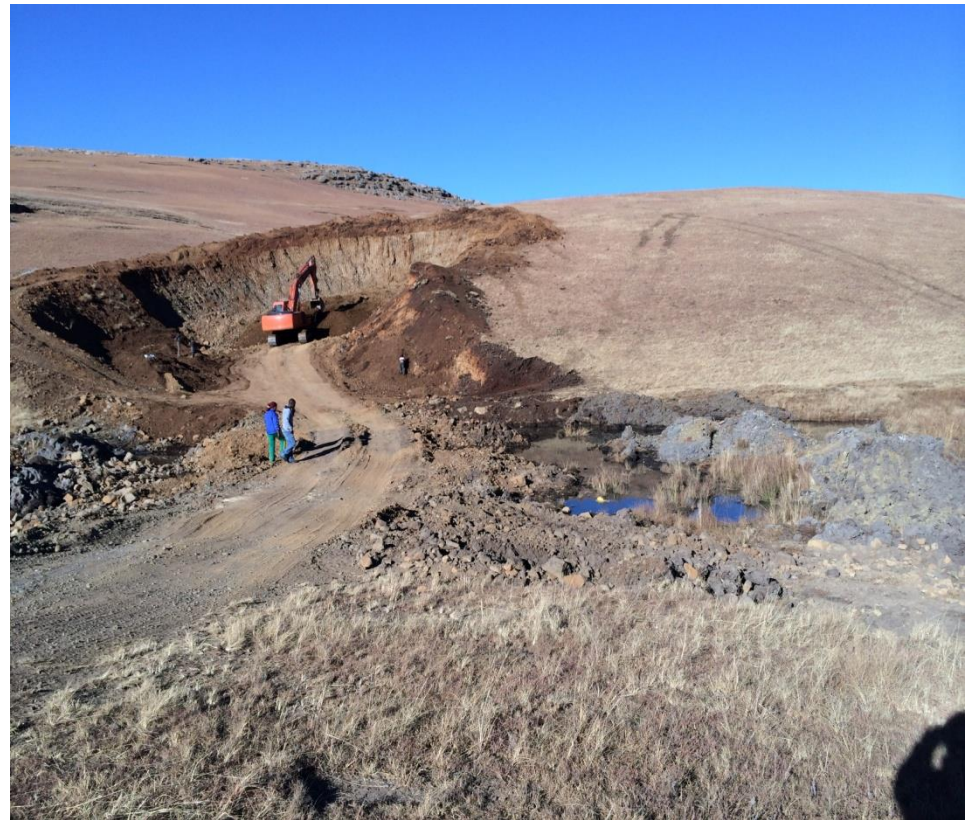
Unauthorized road to the reservoir

13M wide

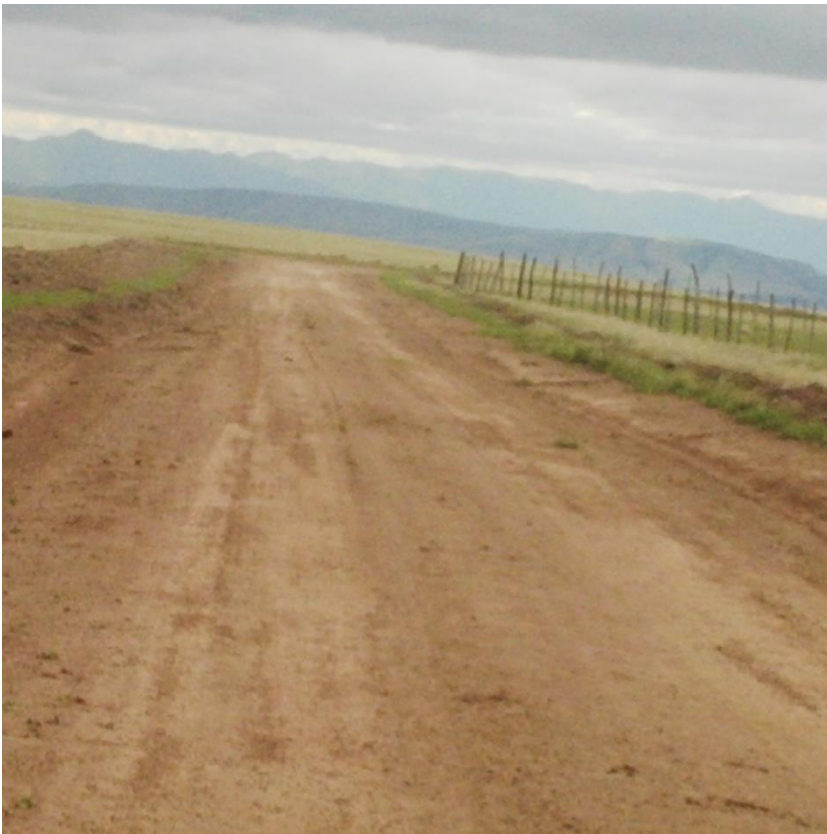
1,4KM long
